2
**CALIFORNIA COAST
STORM DAMAGE
WINTER 1977-1978**

10 PREPARED BY
GEORGE W. DOMURAT
SAN FRANCISCO DISTRICT

CALIFORNIA COAST
STORM DAMAGE
WINTER 1977-78

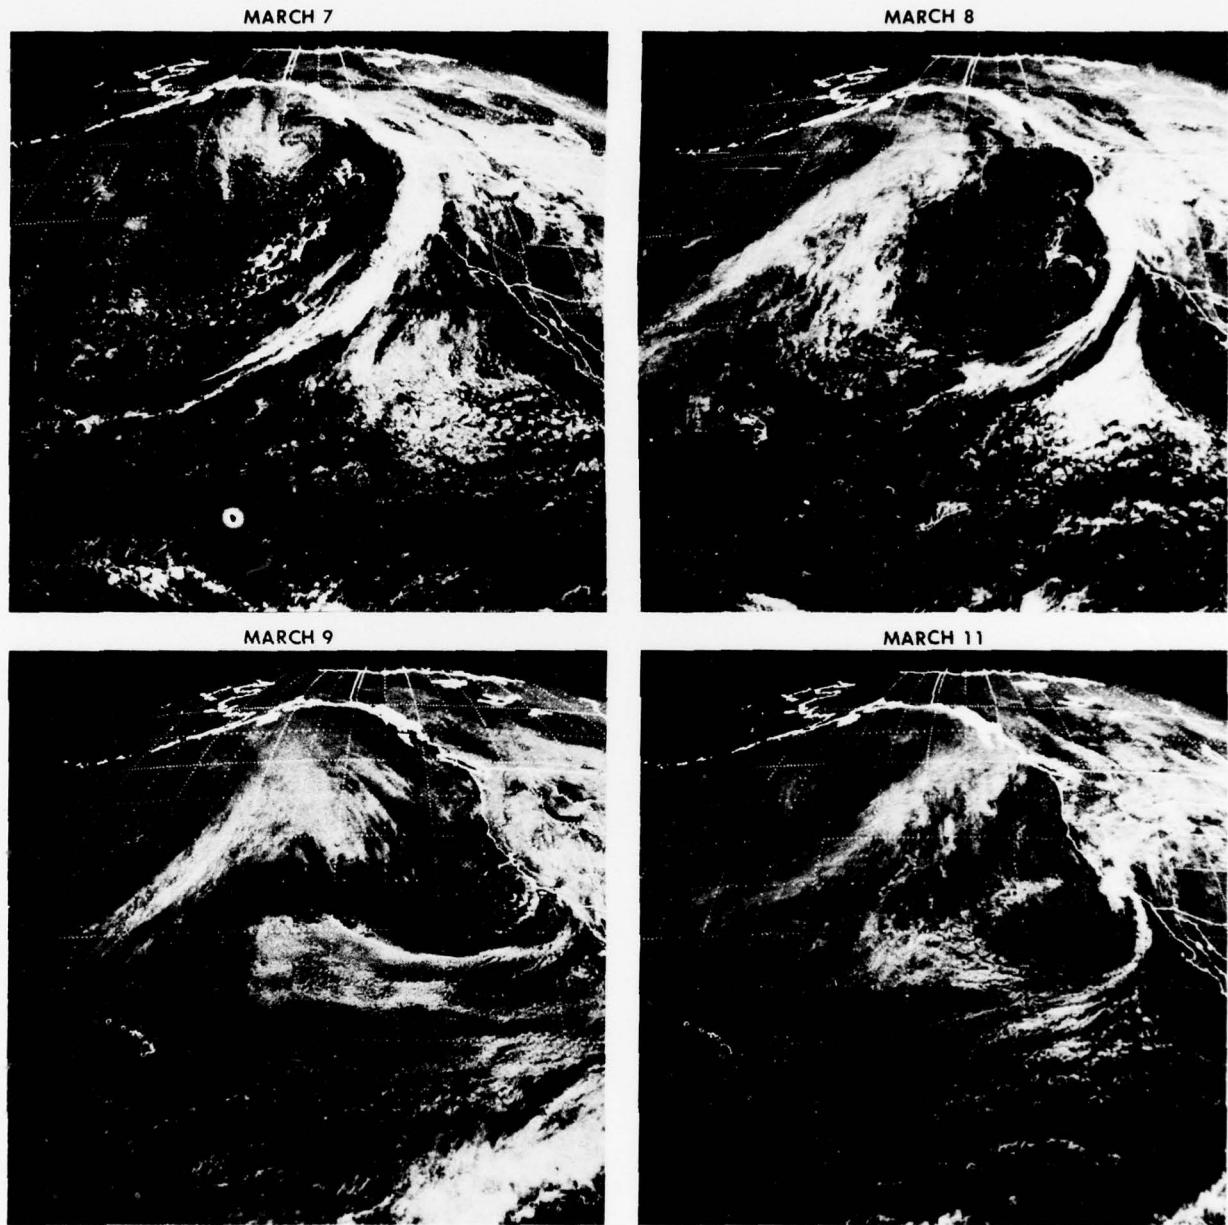
attack higher than normal elevations along the coastline. Figure 1 shows a sequence of satellite photos taken on storm dates 7, 8, 9, and 11 of March, 1978.

FIGURE 1 - EXTRATROPICAL CYCLONE SEQUENCE. (PHOTOS COURTESY OF THE NATIONAL WEATHER SERVICE, SATELLITE DIVISION)

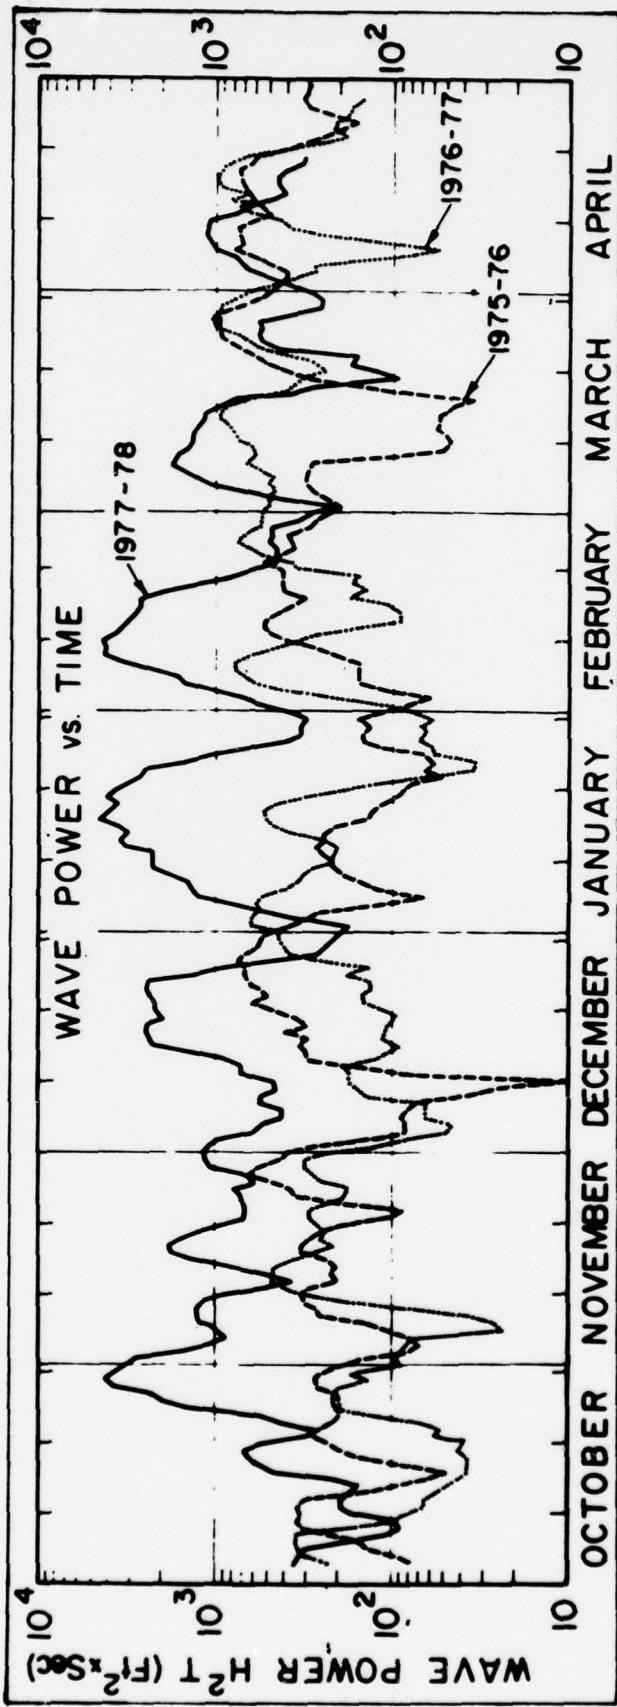
To provide documentation on wave energy this winter as compared with the two previous years, wave data were obtained from the U.S. Navy Fleet Numerical Weather Central (FNWC). For Station 3, in deep water offshore of San Francisco, daily values of wave height, period, and direction were tabulated for the seven-month period (October-April) for the years 1975-76, 1976-77, and 1977-78. The wave power ($H^2 T$) was calculated and tabulated for each day. Figure 2 presents the variation of wave power with time.

It is of interest to note that the winter season of 1976-77 was somewhat more severe than that in 1975-76 as evidenced by the numerous high peaks of wave power, particularly during January-April, 1977. Also note that during the entire winter of 1977-78 the wave power is greatly in excess of that in the previous two years. Severe erosion occurred at numerous beaches along the northern California coast that normally are well protected (see Figure 3).

FIGURE 2 - FIVE-DAY MOVING AVERAGE OF WAVE POWER OFFSHORE IN DEEP WATER FROM SAN FRANCISCO, CA DURING THE SEVEN-MONTH PERIOD OF THE WINTERS OF 1975-76, 1976-77, AND 1977-78.

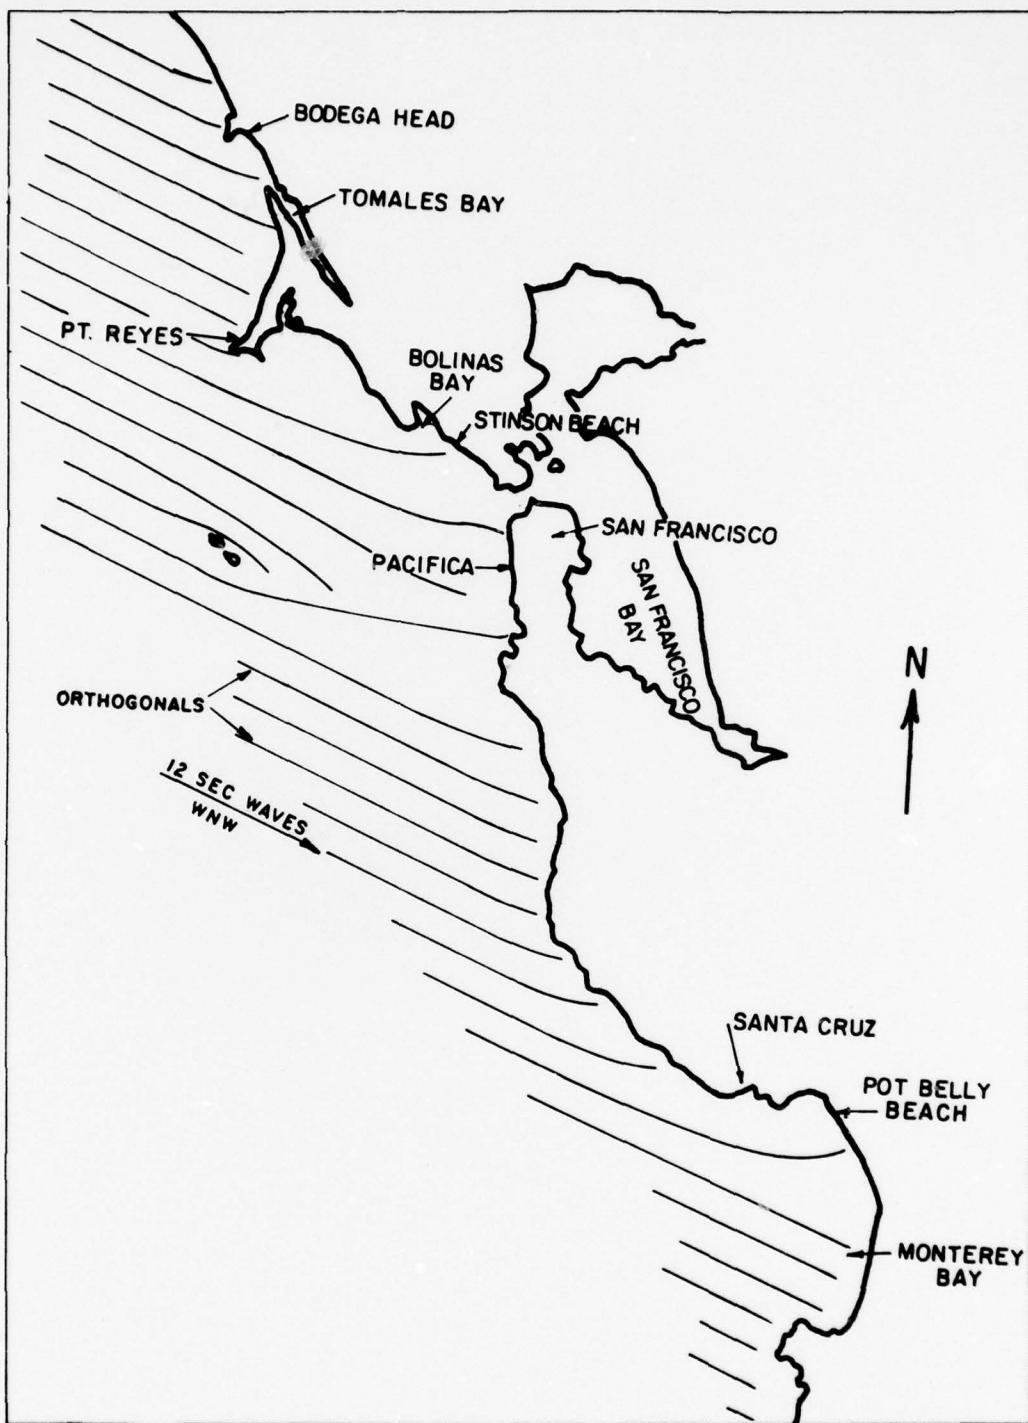
FIGURE 3 - REFRACTION DIAGRAM SHOWING THE NORMAL DEGREE OF WAVE EXPOSURE ALONG THE CENTRAL CALIFORNIA COAST (DIAGRAM IS FOR 12 SEC. PERIOD WAVES FROM WNW).

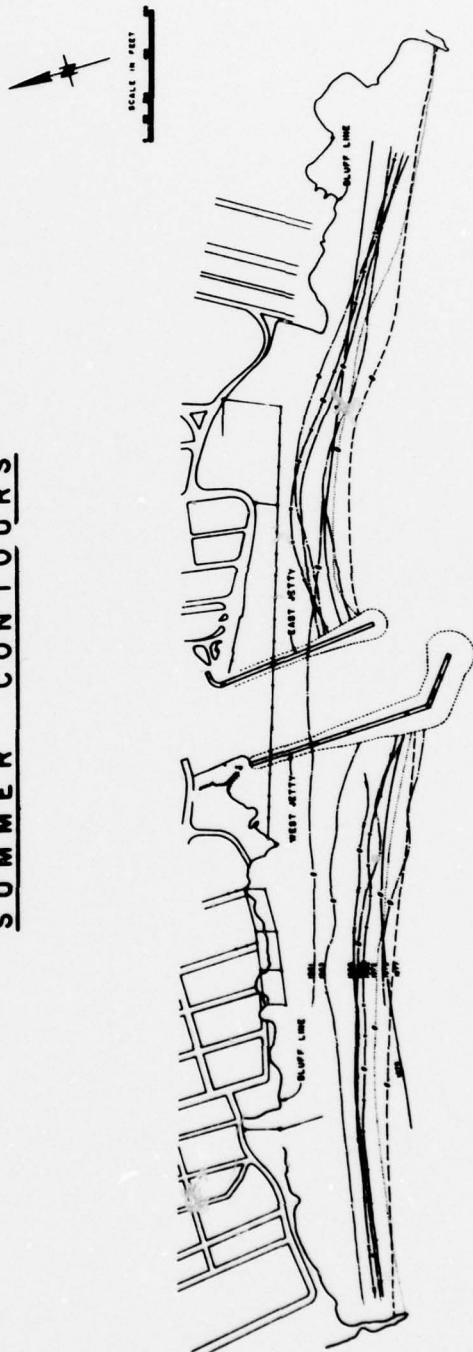
To the veteran beach observer it is a well known fact that large winter waves erode sand from the beach and deposit this material offshore in the form of submarine bars. Low energy waves move this material back onto the beaches during the summer season. The degree of winter erosion is a function of the wave energy being expended on the beach. Figures 4, 5, and 6 present the seasonal variations in shoreline configuration at Santa Cruz, California. Note the line marked February 1978 as compared with previous years.

FIGURE 5 - SEASONAL CHANGES AT SANTA CRUZ, CA
(NOTE FEBRUARY 1978 LINE)

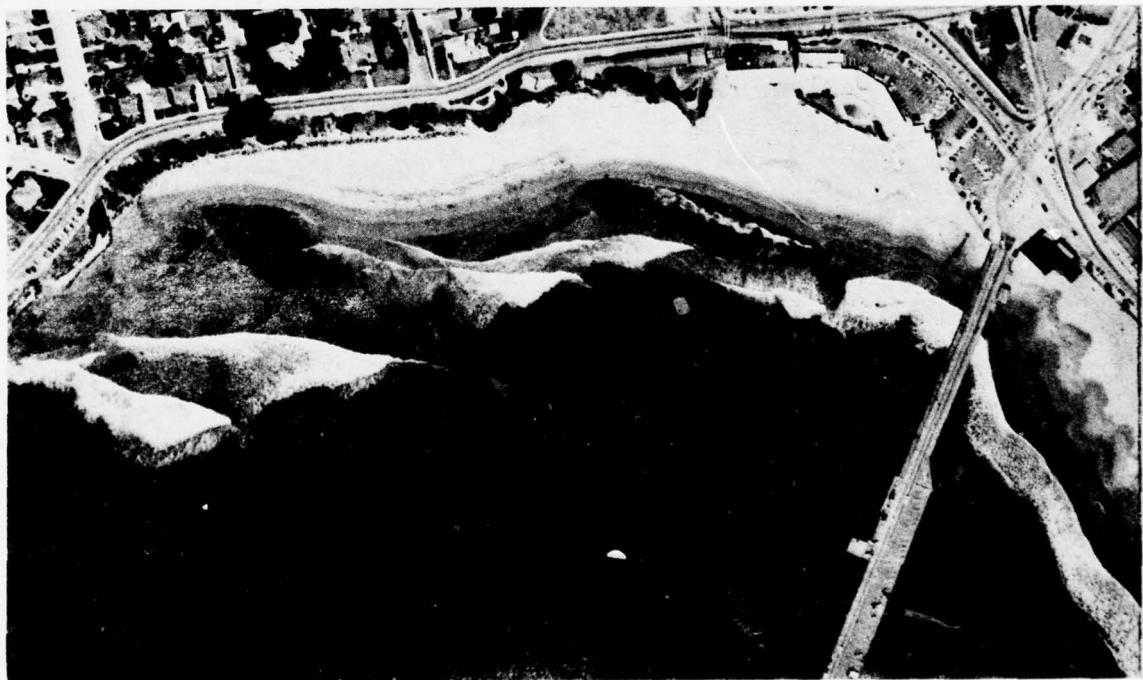
Figures 7 and 8 show the seasonal change in beach width at Santa Cruz Pier for February and May respectively. Wave energy, as pictured in the figures is significantly different between the two seasons.

FIGURE 8 - SHORELINE CONFIGURATION - SUMMER (TAKEN MAY 1978)

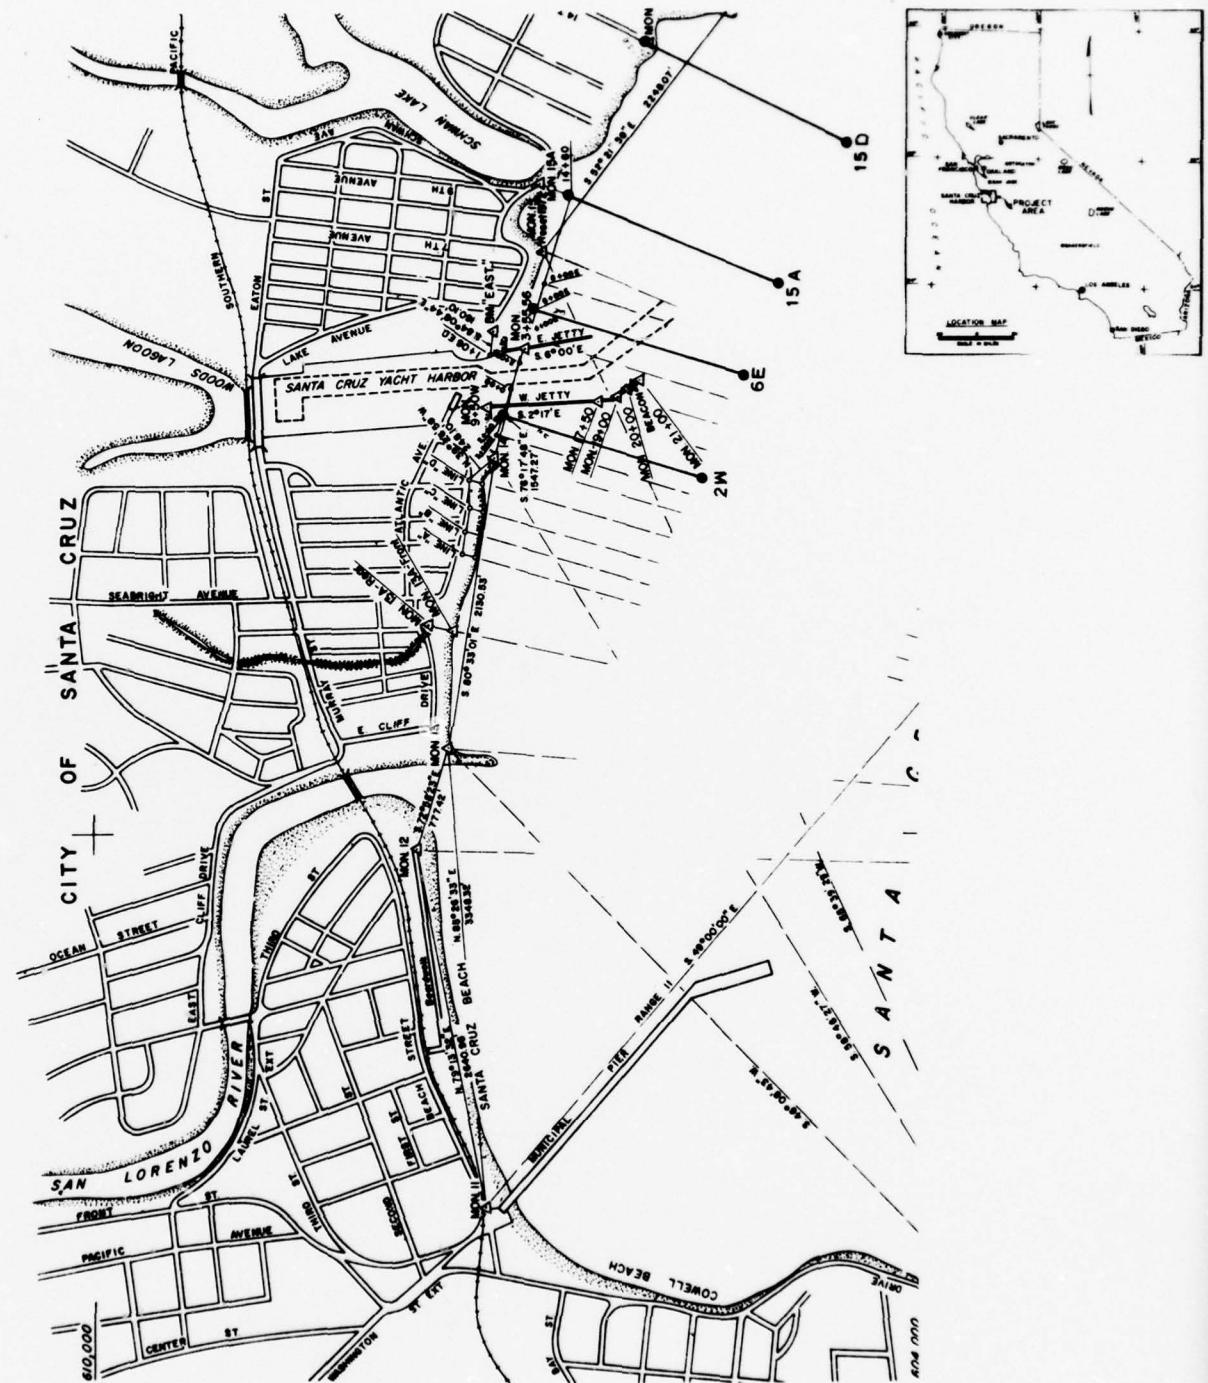
FIGURE 9 - LOCATION OF PROFILE LINES AT SANTA CRUZ, CA

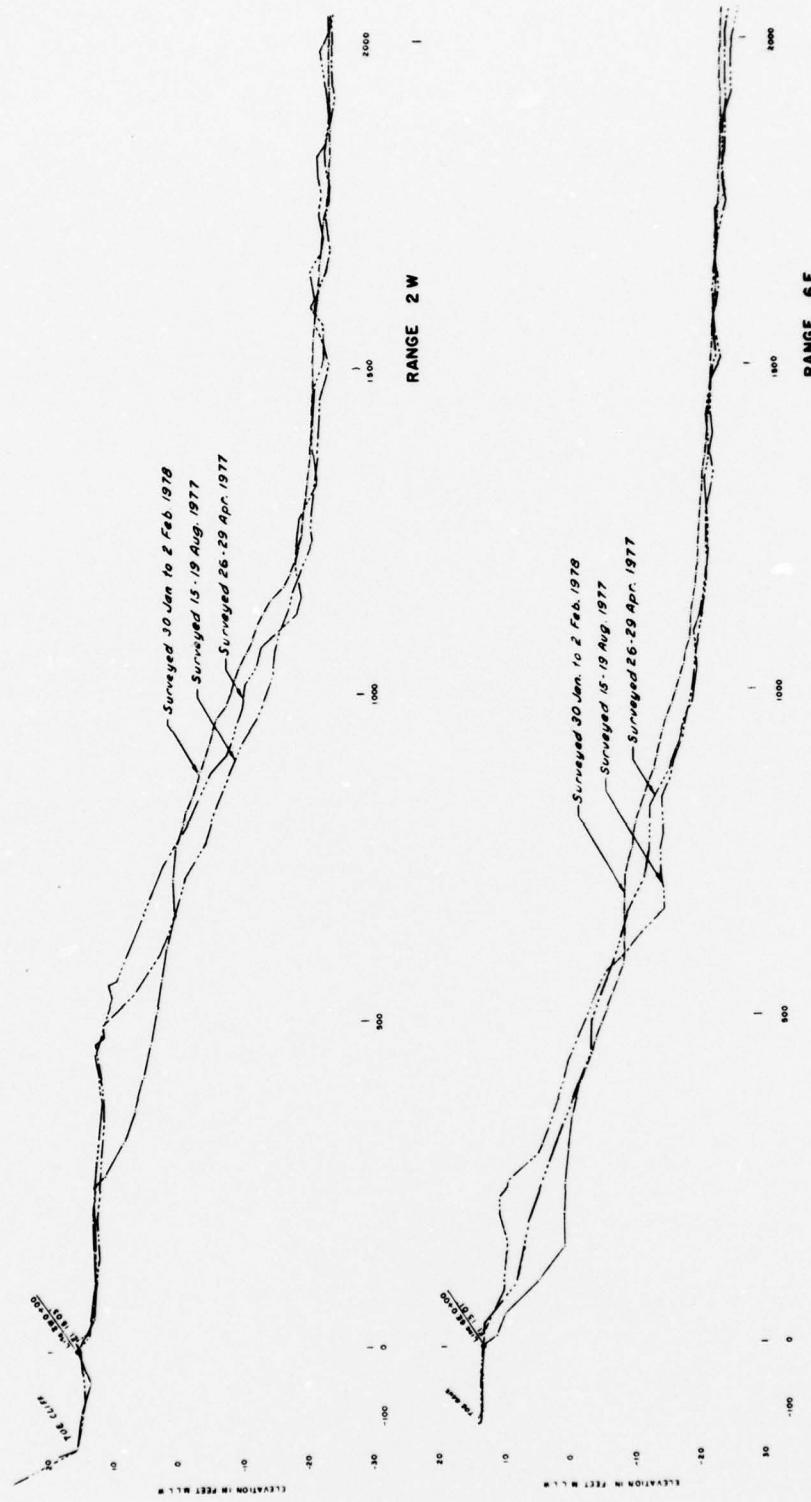
The extent of beach erosion may also be quantified by comparing beach profiles collected at Santa Cruz and also at various piers along the Southern California Coastline. Figure 9 locates the profiles presented in Figures 10 and 11. Note that in some areas up to 10 feet

FIGURE 10 - HYDROSURVEYS OF BEACH AND NEARSHORE ZONE, SANTA CRUZ, CA

(vertical) were lost between the period August 1977 and February 1978.

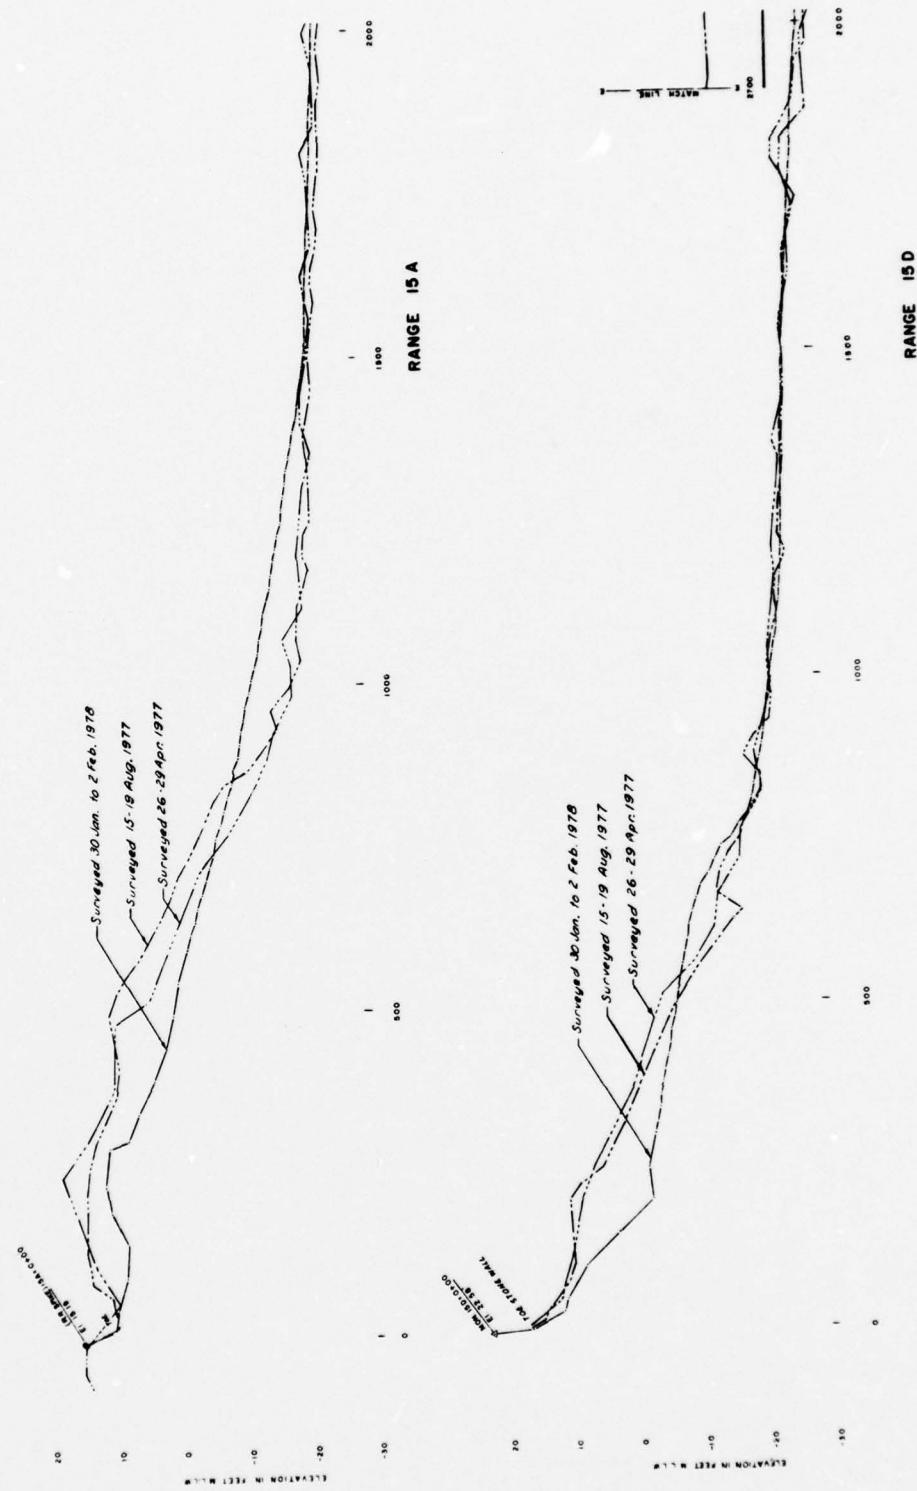
FIGURE 11 - HYDROSURVEYS, SANTA CRUZ, CA

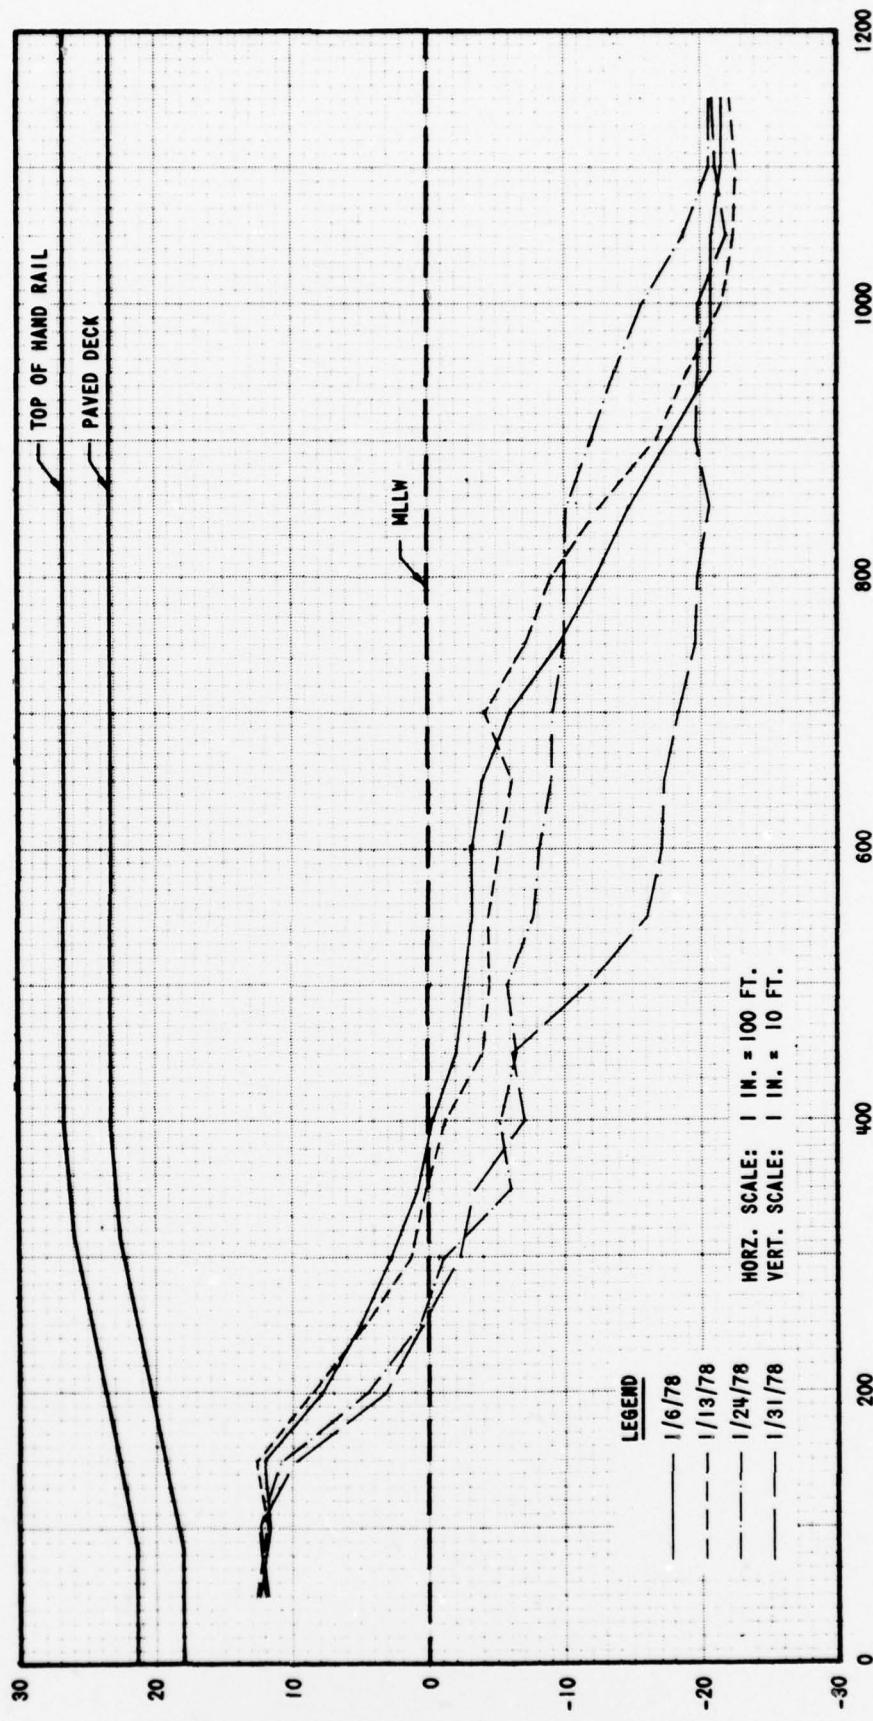
FIGURE 12 - IMPERIAL BEACH PIER PROFILES FOR JANUARY 1978

At Imperial Beach Pier an average of 3 feet (vertically) was lost during the period January 1978 to March 1978 (see Figures 12, 13, 14).

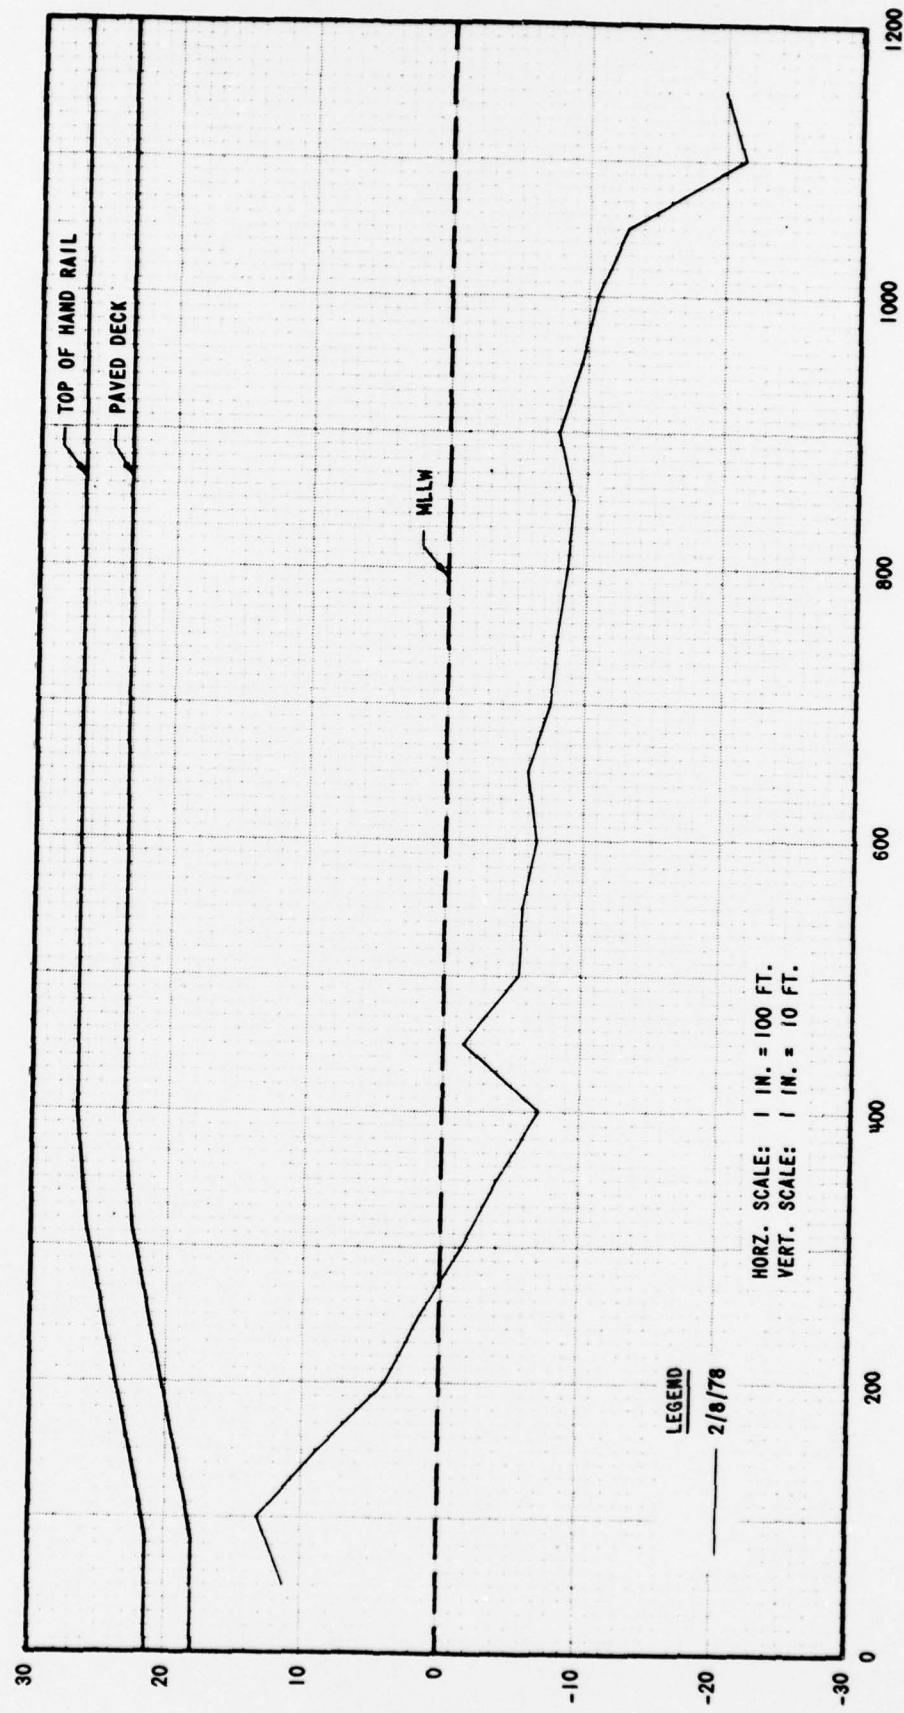
FIGURE 13 - IMPERICAL BEACH PIER PROFILE FOR FEBRUARY 1978

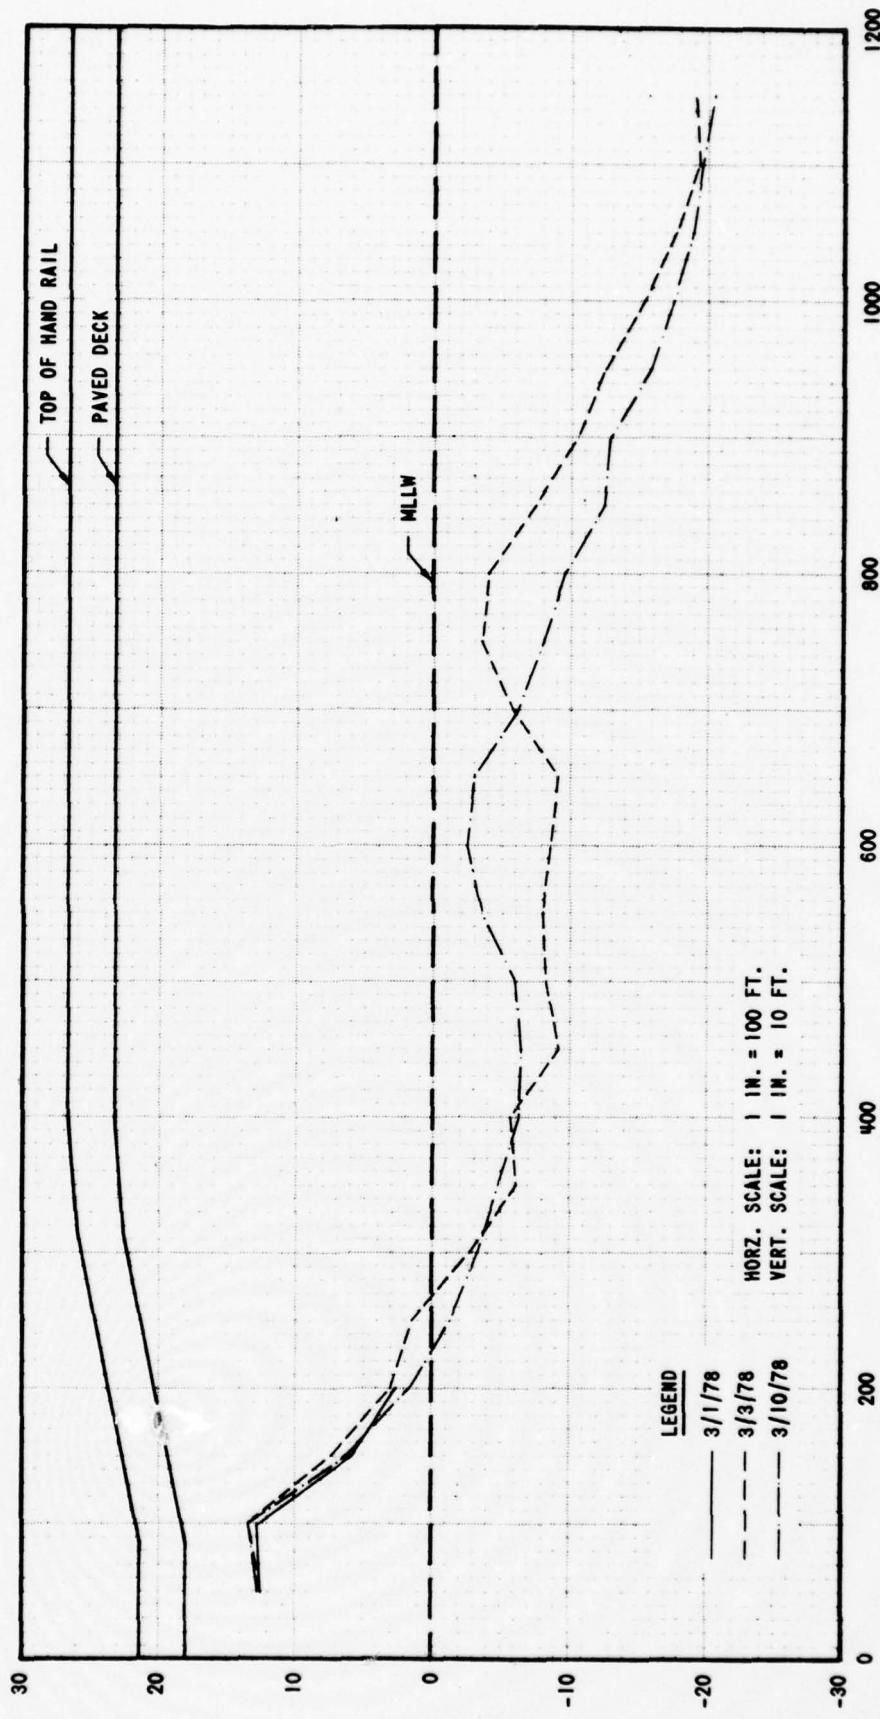
FIGURE 14 - IMPERIAL BEACH PIER PROFILES FOR MARCH 1978

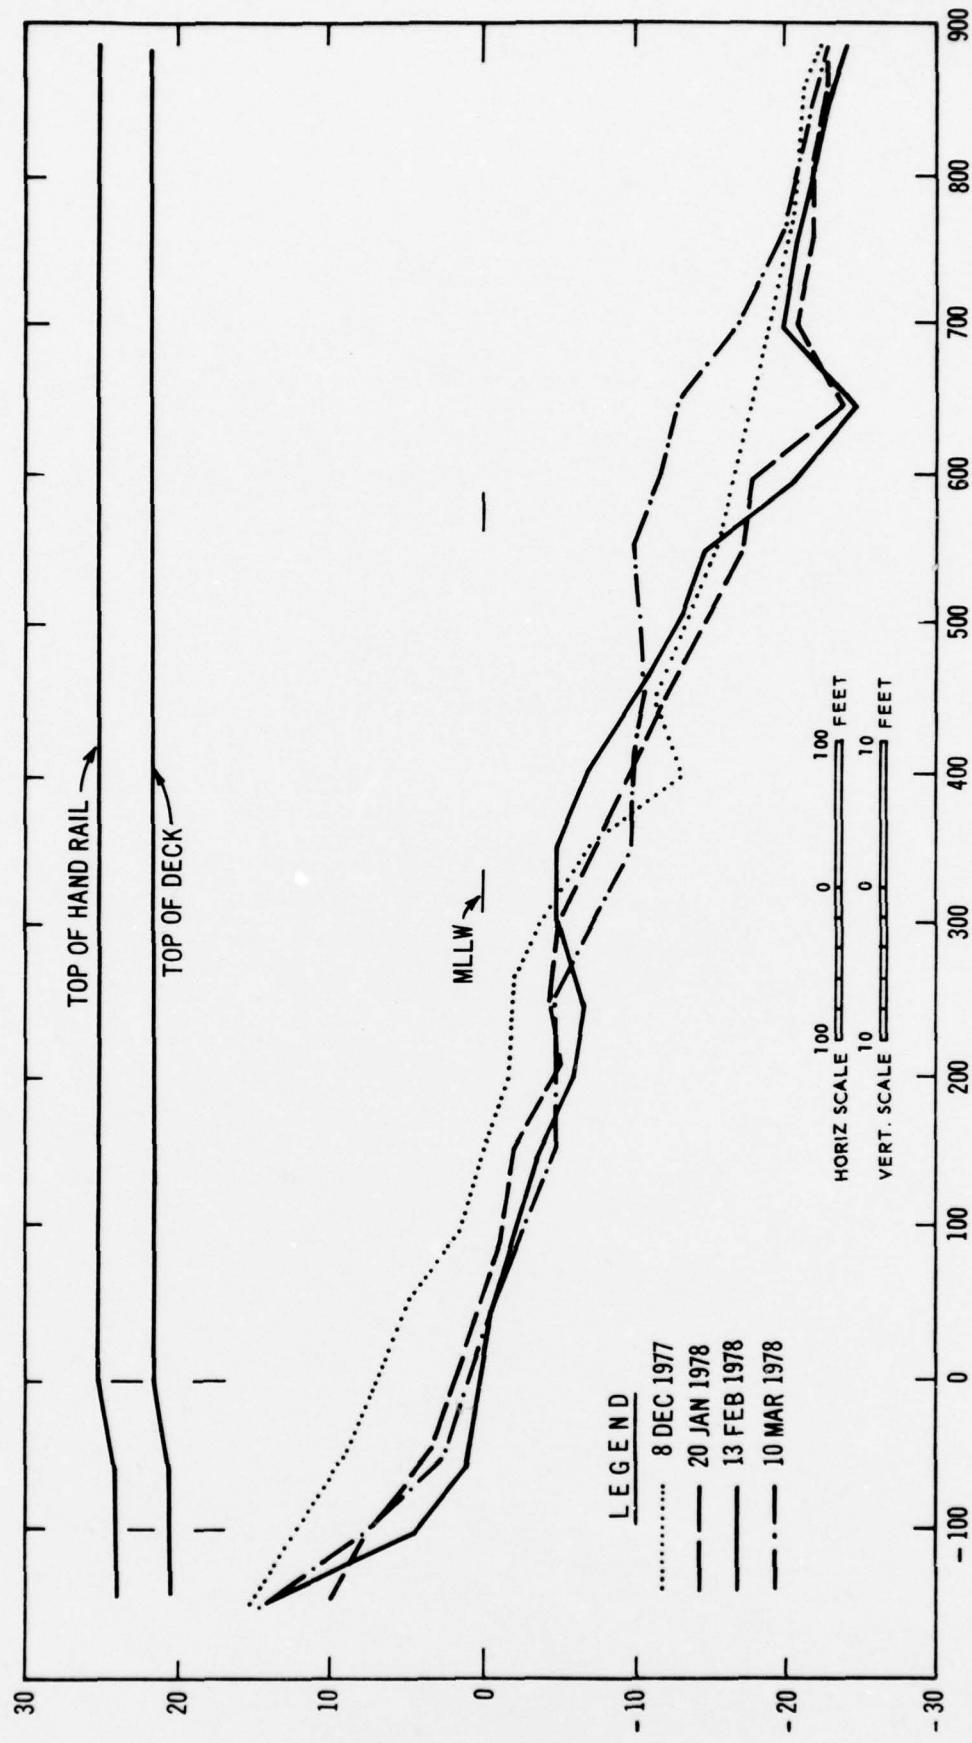
FIGURE 15 - PROFILES FROM HUENEME PIER IN SOUTHERN CALIFORNIA

At Hueneme Pier (Figure 15) in Ventura County, the beach lost an average of 5 feet vertically between the +12 to -10 foot contours. These pier profiles were taken weekly from Hueneme Pier.

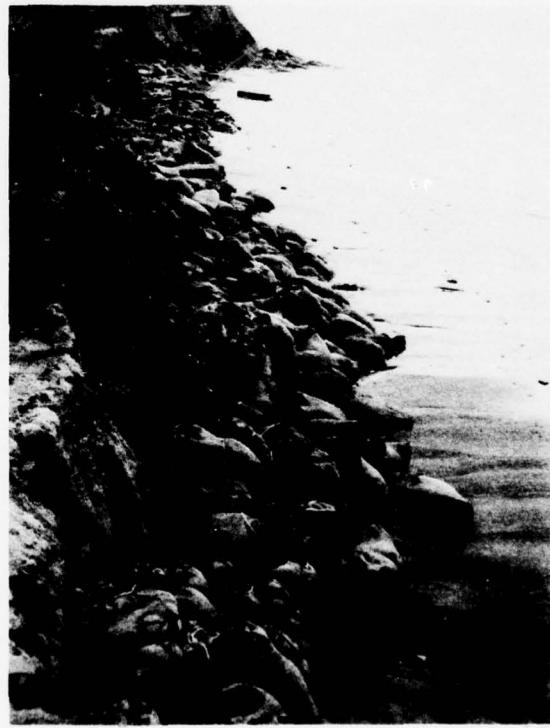
FIGURE 22 - SANDBAGS PROTECTING THE DUNE SCARP AT SEADRIFT SPIT

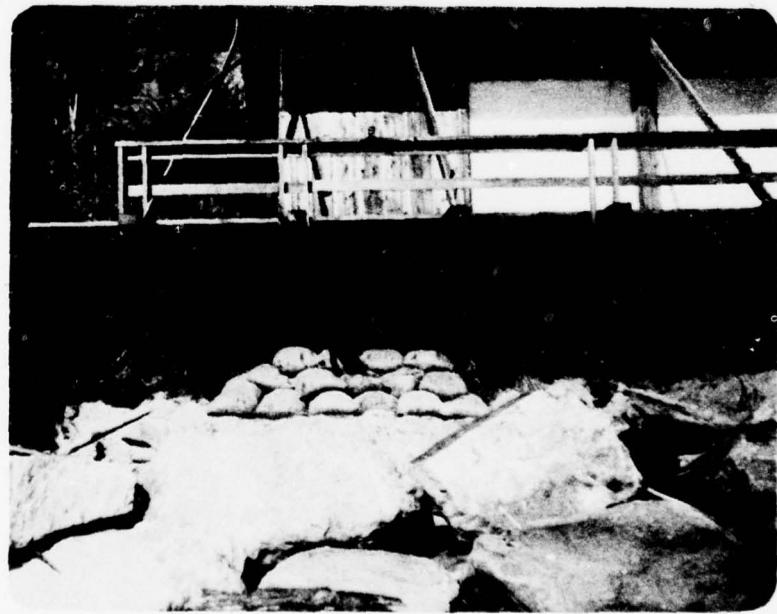
Further downcoast in the Monterey Bay area, private homeowners were faced with the problems of cliff erosion and loss of beach and dune material. At Potbelly Beach (Figures 25 and 26) concrete patios collapsed and dwelling foundations were exposed. Potbelly Beach residents grouped together and financed the temporary implacement of 2-5 ton rock riprap as protection against further erosion.

FIGURE 26 - UNDERMINING OF STRUCTURES BY WAVE ACTION
(POTBELLY BEACH, CA)

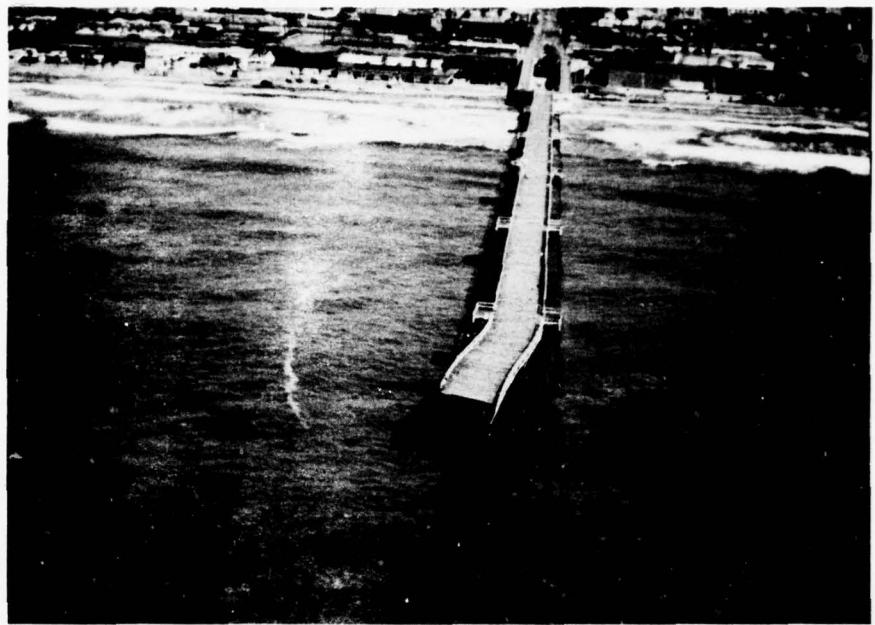
Oceanside Beach lost up to 300,000 cubic yards of beach fill placed in the area before the winter storms (see Figures 27 and 28). As can be seen in Figures 29, 30, 31 and 32 damage to Oceanside Municipal Pier and the navigation lights on the north and south breakwaters was extensive. The seaward 300 feet of the pier was destroyed along with the south jetty navigation light foundation. Rock at the end of the north breakwater was displaced so as to undermine the entire foundation of the navigation light. The Oceanside Harbor Department placed rock on storm damaged seawalls in the interior harbor at a cost of \$18,000. Estimate for repair of the north breakwater and south jetty is \$375,000. A total dollar figure for San Diego County area, as supplied by the California State Office of Emergency Services, is \$15,600,000, of which \$9,400,000 was damage to public property.

FIGURE 29 - DAMAGE SUSTAINED BY OCEANSIDE MUNICIPAL PIER

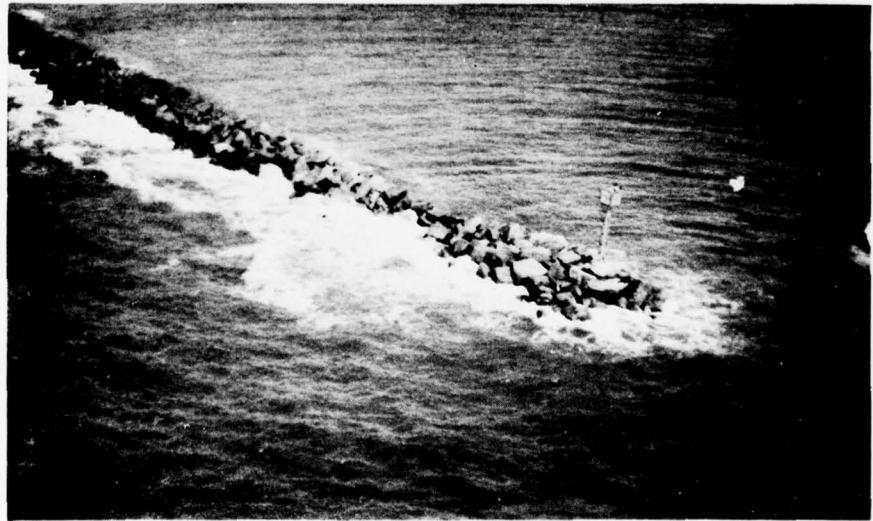
FIGURE 30 - NORTH JETTY, OCEANSIDE HARBOR AFTER THE WINTER STORMS
